It took place on Wednesday, March 23, 2005 at the Texas City Refinery of BP Products North America Inc. During the startup of the Isomerization Unit, explosions and fires occurred, killing fifteen and harming over 170 persons apart from extensively destroying property within the plant and the surrounding area.

Can you afford a "TEXAS CITY" Accident?

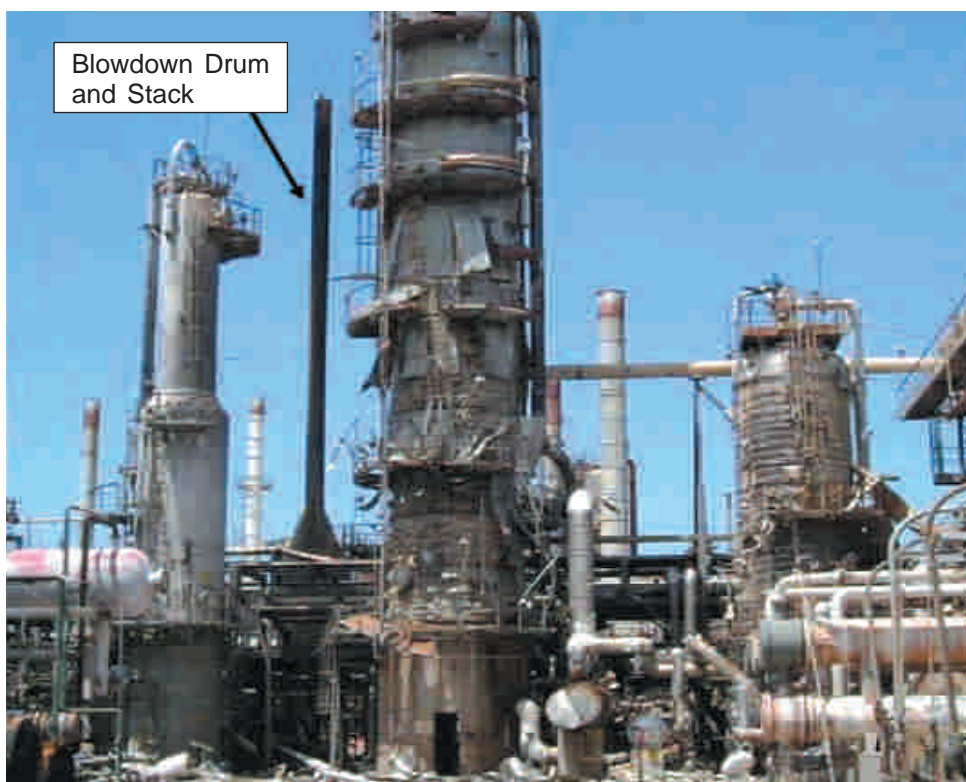
Picture showing the offending blowdown drum and stack that were the initiating points of the fire.

4. Committing US\$1 billion over the next five years to upgrade and maintain the Texas City site. Among other things, BP would be installing modern process control systems on major units, eliminating the use of blow down stacks in light service and improving workforce training.
